**AIRCRAFT TRANSPARENCY FAILURE & LOGISTICAL
COST ANALYSIS — SUPPLEMENTAL STUDY**

Rockwell International
North American Aircraft Division
P.O. Box 92098
Los Angeles, CA 90009

Technical Report AFFDL-TR-79-3083
Final Report for Period February-June 1979

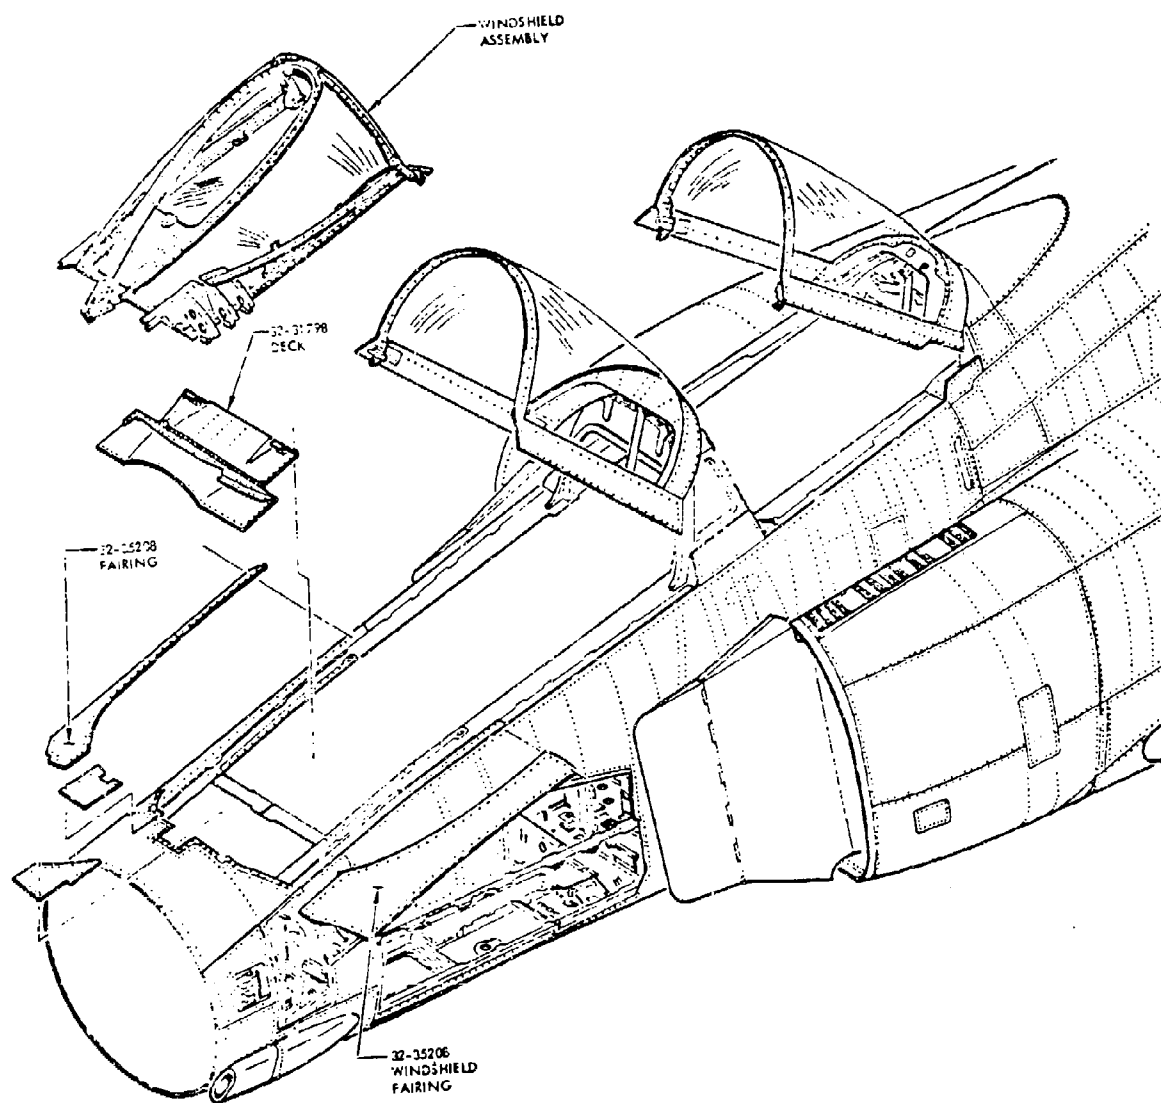
Figure 3. F-4 Transparency Configuration

WUC IIIAP W/S GLASS SIDE L.H.
WUC IIIAN W/S GLASS SIDE R.H.
WUC IIIAQ W/S PANEL FLAT CENTER

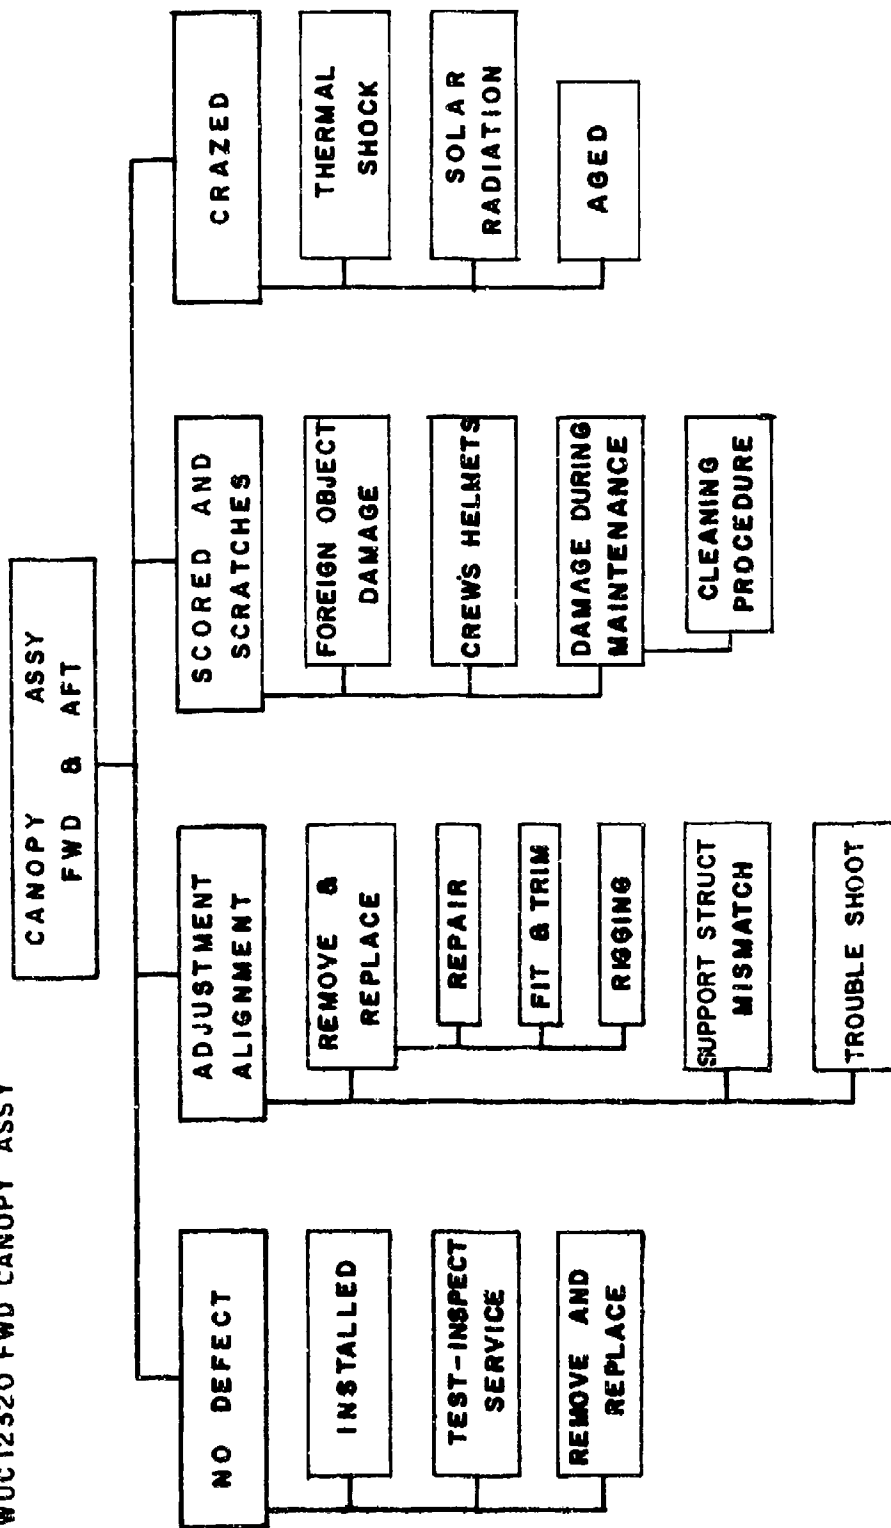
Figure 5. Fault Tree F-4 Forward and Aft Canopy Assemblies

WUC12350 AFT CANOPY ASSY
WUC12320 FWD CANOPY ASSY

An assessment of the component failures from the MAM's was made. These were condensed in the form of a failure fault tree (figures 4 and 5) and a failure analysis summary (figures 6 and 7) of the more significant How-Mal's, action taken, and probable cause.

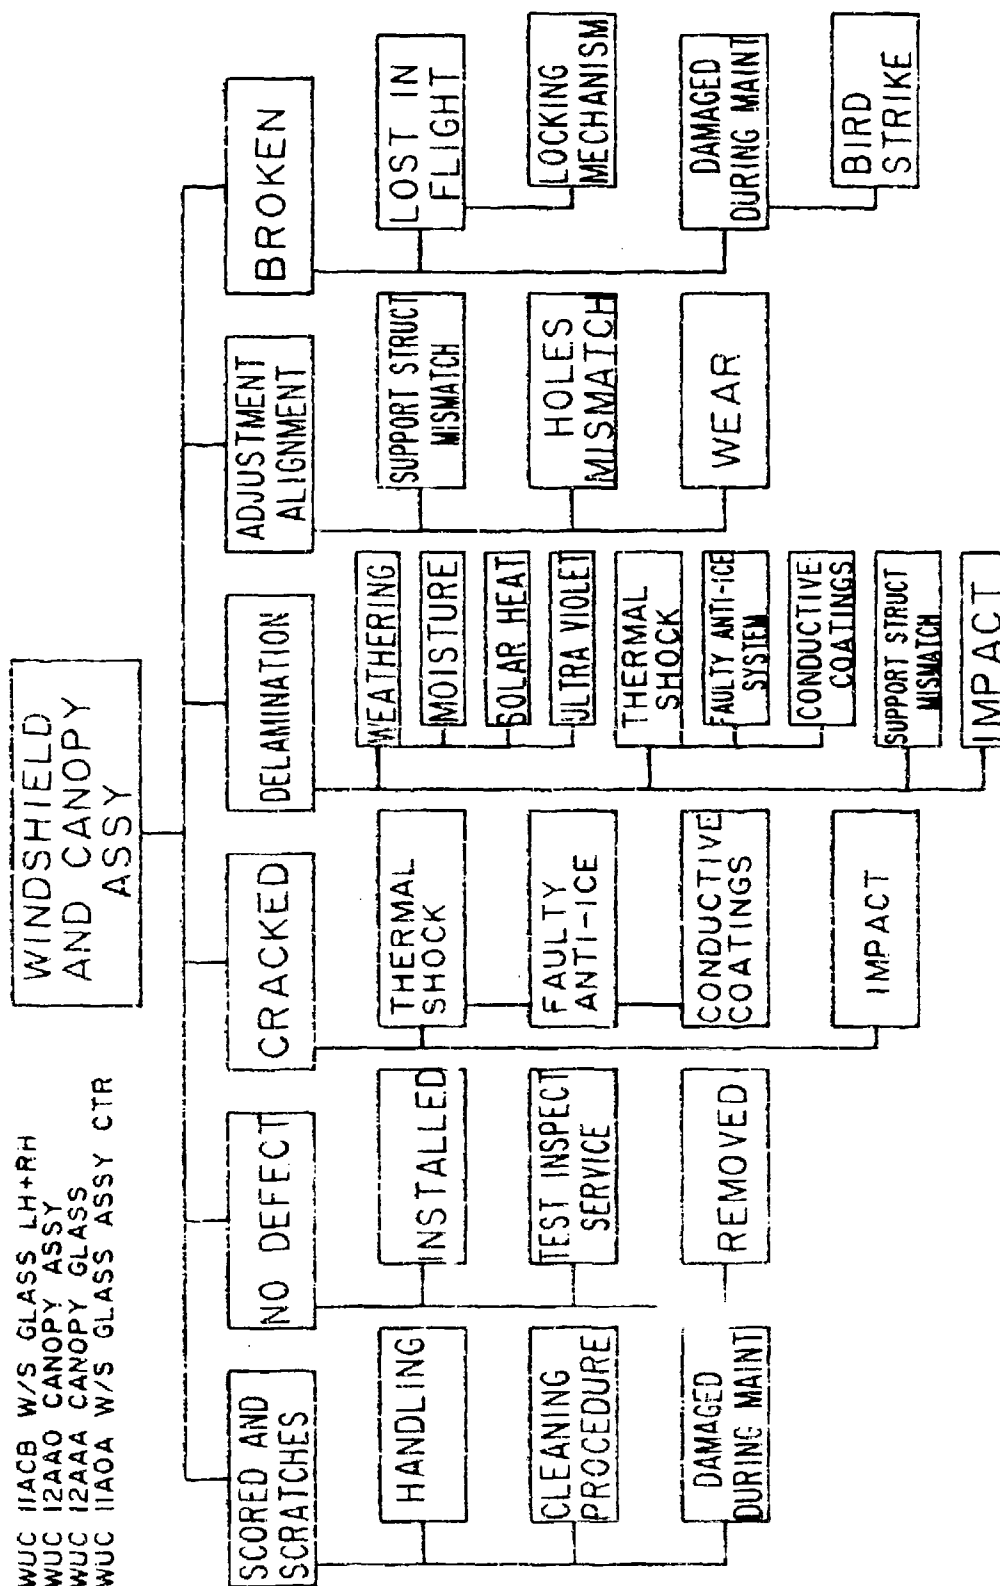
Figure 17. Fault Tree A-7D Windshield and Canopy Assemblies

WUC 11ACB W/S GLASS LH+RH
 WUC 12AAO CANOPY ASSY
 WUC 12AAA CANOPY GLASS
 WUC 11AOA W/S GLASS ASSY CTR

An assessment of the A-7D transparency system failures as extracted from the maintenance analysis (MAM's) program plus the failures obtained from field audit were compiled in the form of a fault tree as shown in figure 17. The conclusions reached after study and rationalization of the How-Mals and field experiences were then assembled and summarized in figure 18. The major problems that surfaced from these data were:

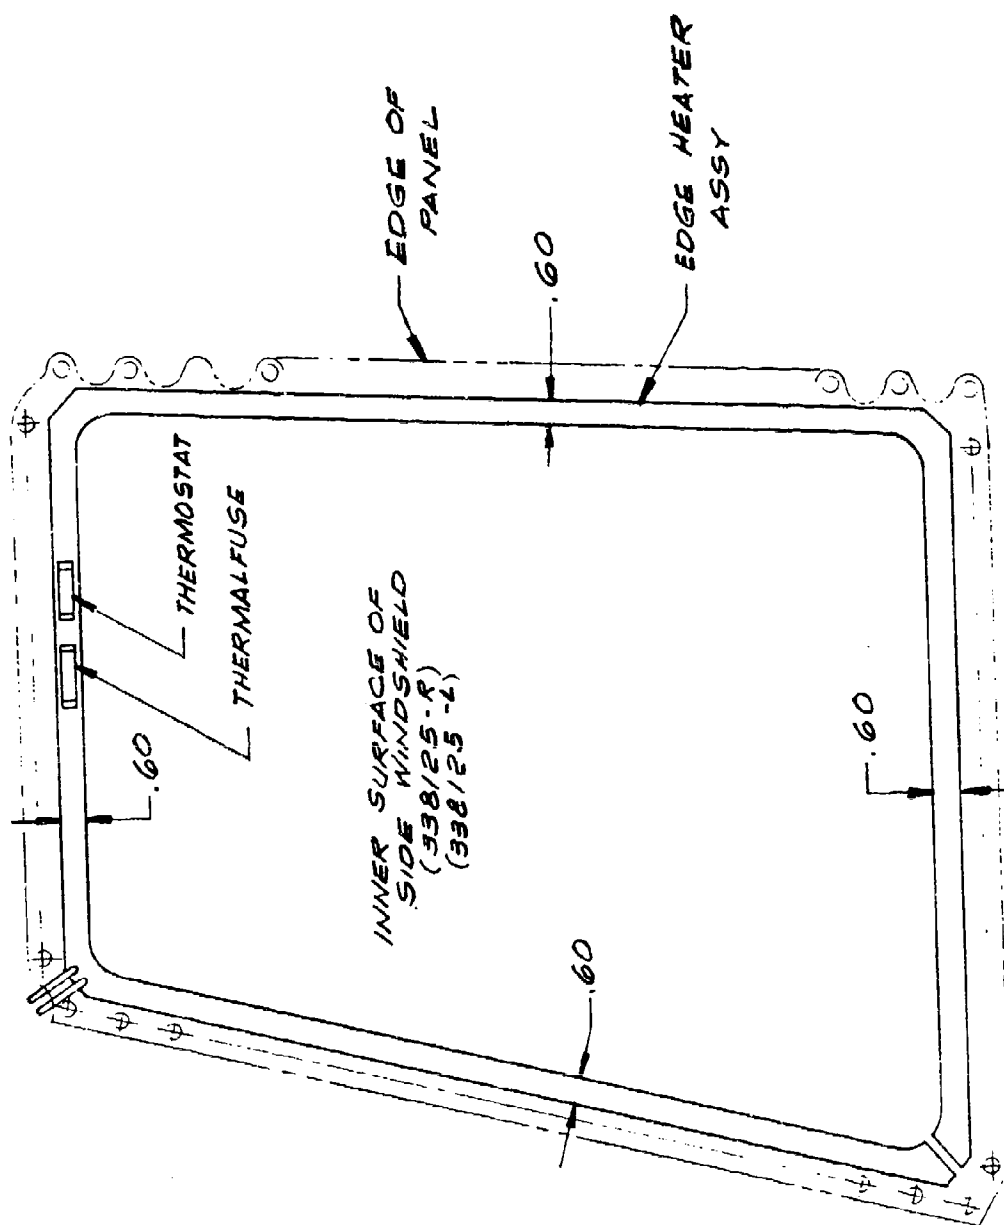
Figure 24. C-130 Windshield Panel Edge Heater Installation

TYPICAL EDGE HEATER INSTALLATION

The maintenance people that are experienced with C-130 windshields state that cracking is largely due to thermal shock, service aging, and installation procedures. Further study of these factors indicates that under certain conditions, the temperature differential between the center of the panel and the edge causes a thermal variation that is the probable cause of a portion of the cracking problem. It is therefore recommended that an edge heater be incorporated to reduce this type of failure. (See figure 24.) The additional benefit of this change is the added protection against delamination.

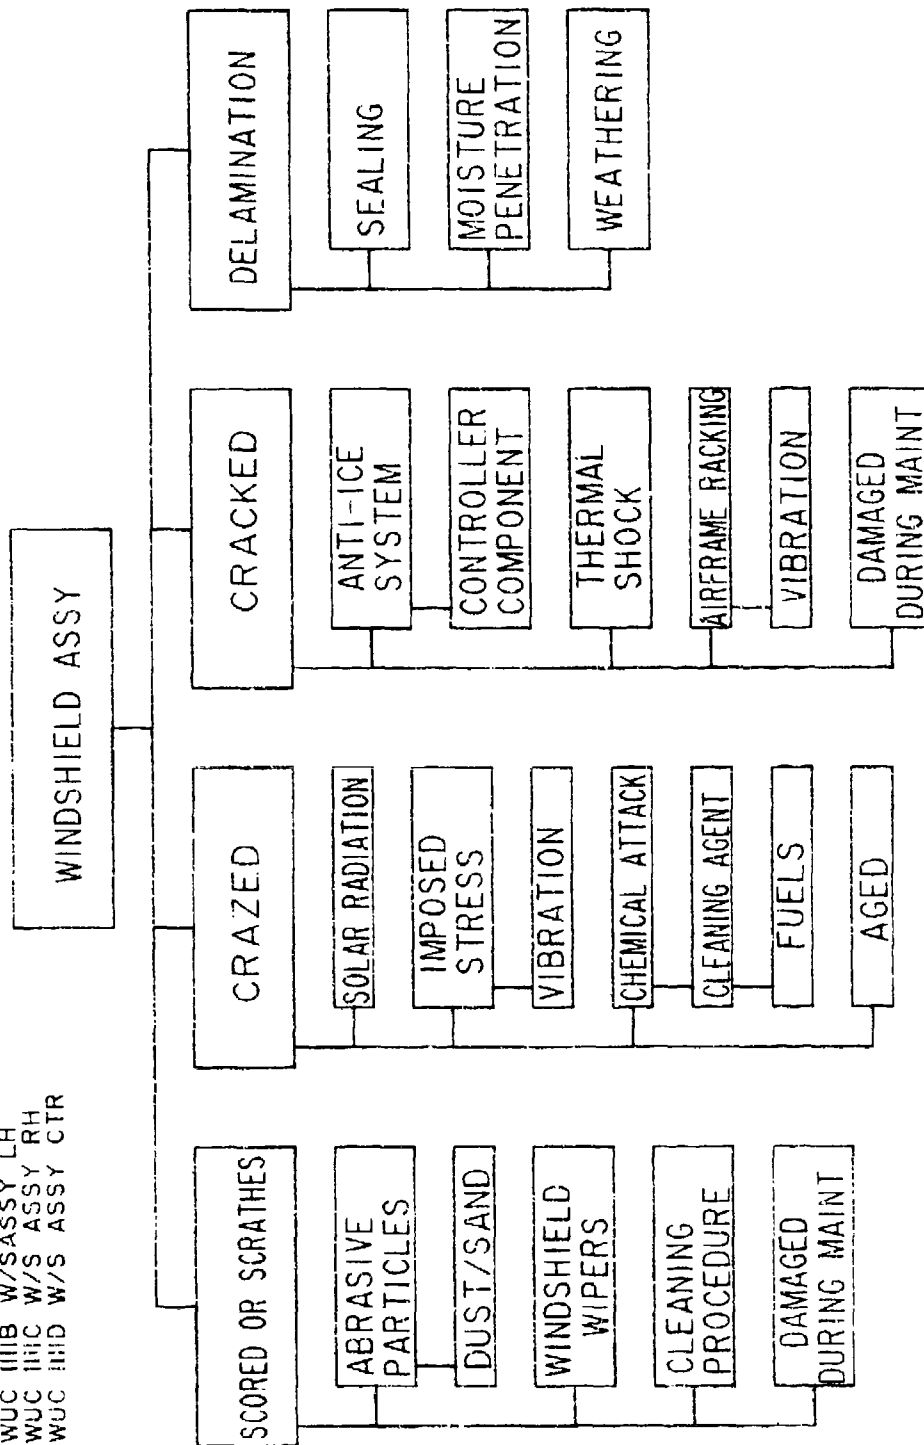
Figure 28. Fault Tree QI-53 Windshield Assembly

WUC IIIB W/SASSY LH
WUC IIIC W/S ASSY RH
WUC IIID W/S ASSY CTR

The description of these failures as diagramed in the fault trees, figures 28 and 29, were assembled from the MAM's program. Figures 30 and 31 present and summarize the more significant How-mals, action taken, and probable cause of failure. The failure mode descriptors in combination with flight hours, maintenance hours, and logistical cost are contained in the sampling MAM's tabulation shown in figure A-4 of Appendix A.

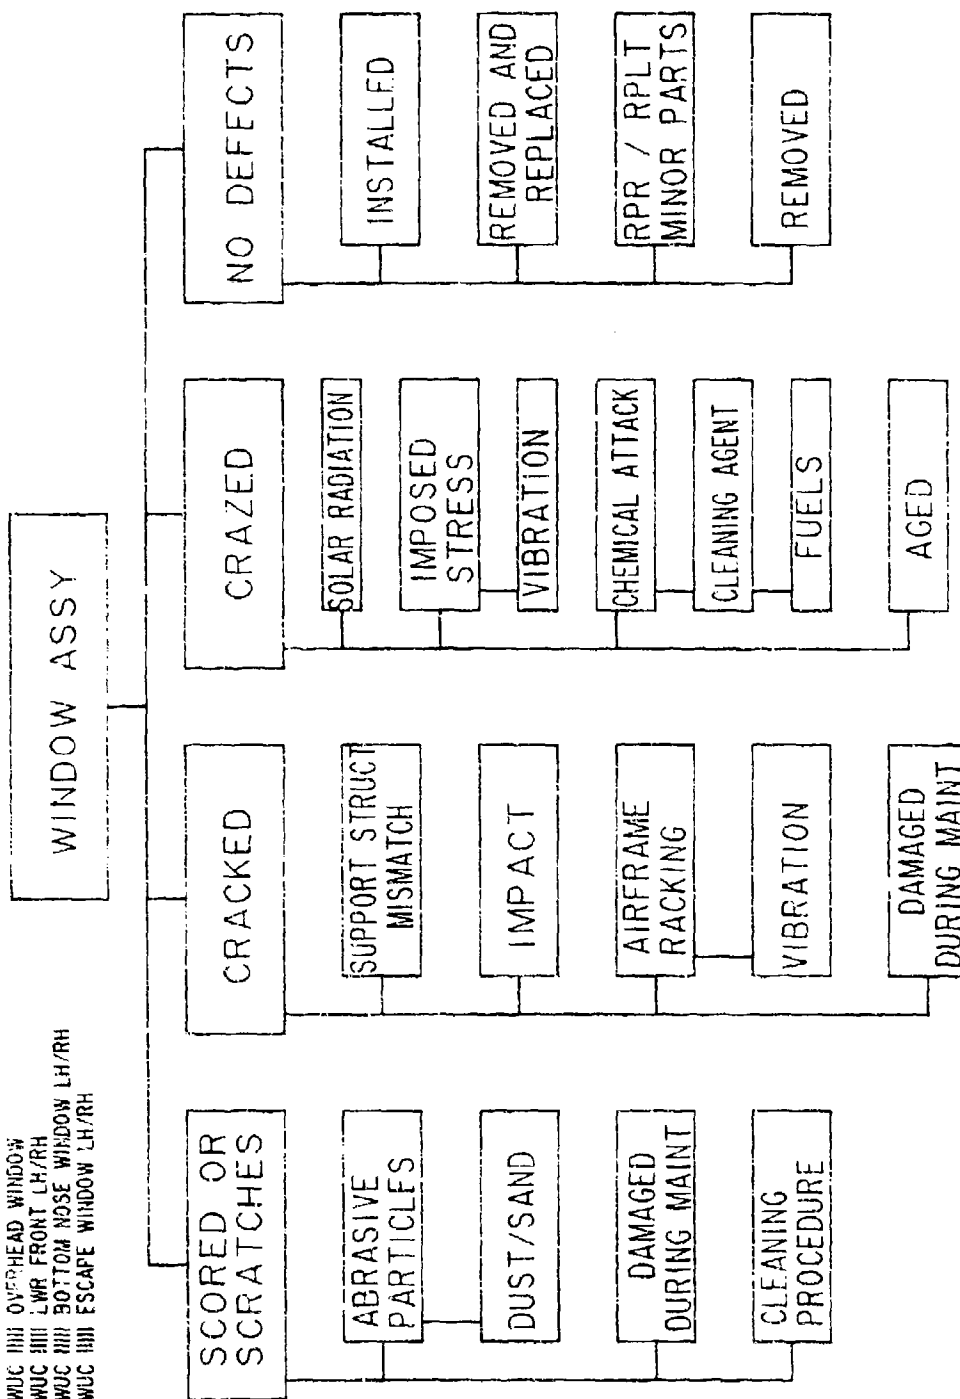
Figure 29. Fault Tree GI-53 Window Assembly

WUC IIII OVERHEAD WINDOW
 WUC IIII LWR FRONT LH/RH
 WUC IIII BOTTOM NOSE WINDOW LH/RH
 WUC IIII ESCAPE WINDOW LH/RH

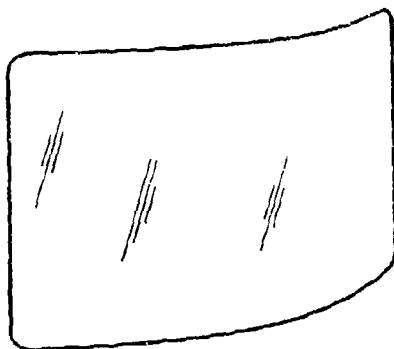
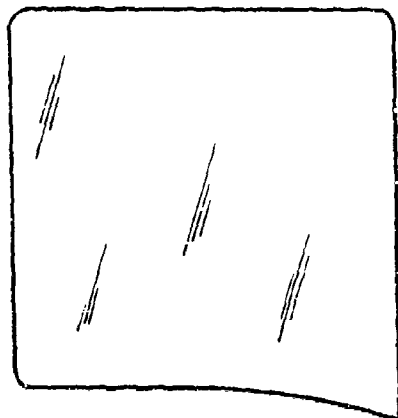
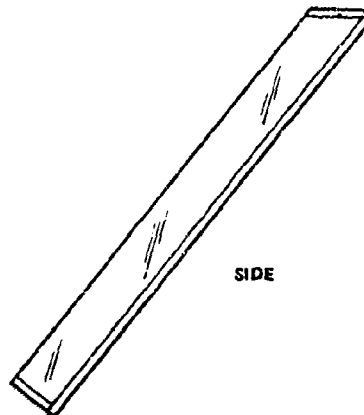
Figure 43. CH-3, Pilot's and Copilot's Windshield Panels

S6120-61228-1, -2, -3 OR -4
TWO PLIES 0.125 IN. GLASS WITH 0.080 IN. INTERLAYER
PER MIL-G-25871 (HEATED WINDSHIELD)
S6122-87171-1 OR -2
0.060 IN. CR-39 FACE PLY, 0.075 IN. INTERLAYER AND
0.150 IN. ACRYLIC, MIL-P-25690 INNER PLY (UNHEATED)
S6122-87172-1 AND -2
0.060 IN. FACE PLY SIERRACIN 900 OR CR-39,
0.075 IN. INTERLAYER, 0.150 IN. ACRYLIC,
MIL-P-25690 INNER PLY (HEATED)

The proposed change to significantly reduce or eliminate the scratching and abrasion problems is to incorporate a multilaminate glass, acrylic, and PPG-liner material configuration for the pilot's and copilot's windshield assemblies. The existing design consists of an inner and outer ply of stretched acrylic with a PVB interlayer as shown in figure 43. The proposed design (see figure 44) is also configured as a multilaminate construction. The outer ply is 0.050-inch Chemcor glass to provide protection against scratching and spalling. For improved resistance to cold chipping, a PPG 112 interlayer (0.057-inch) is recommended. The remaining plies consist of an outer layer of 0.020-inch PPG-liner material bonded to a 0.150-inch stretched acrylic structural ply.

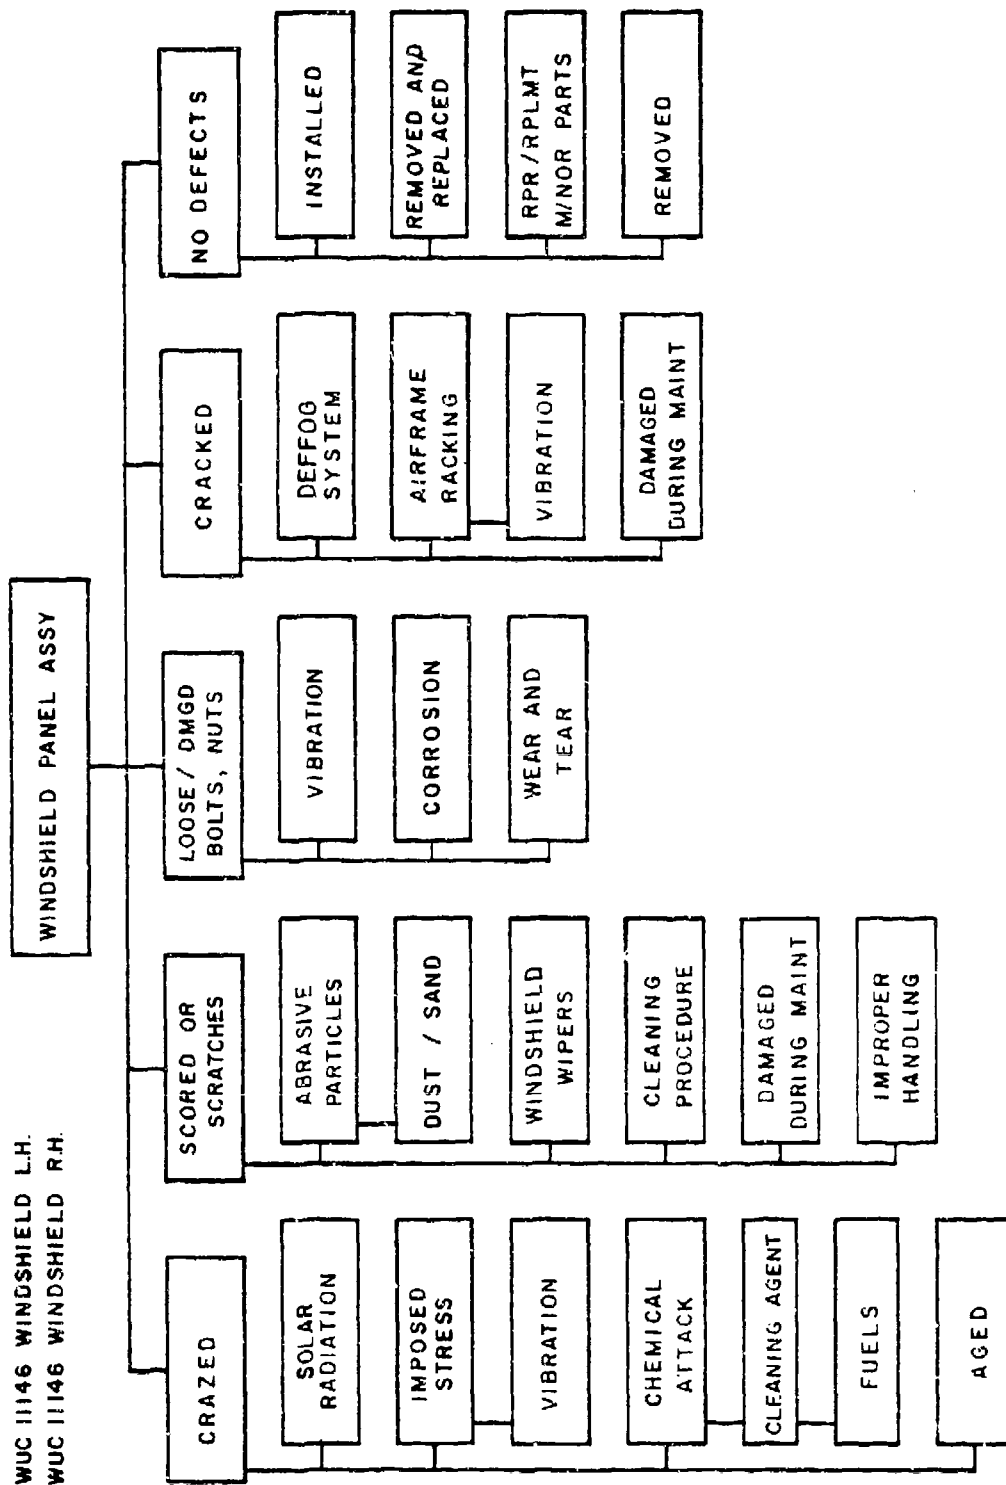
Figure 46. Fault Tree UI-1/P Windshield Panel Assemblies

WUC 11146 WINDSHIELD L.H.
WUC 11146 WINDSHIELD R.H.

The description of these failures as diagramed in the fault trees, figures 46 and 47, was assembled from the MAM's program. Figures 48 and 49 present and summarize the more significant How-Mal's, action taken, and probable cause of failure. The failure mode descriptors in combination with flight hours, maintenance hours, and logistical cost are contained in the sampling MAM's tabulation shown in figure A-6 of Appendix A.
